March 2, 2006

**Re: Letter Report on a Historic Building Review of a Spanish Colonial Revival House
Located on Culebra Road, San Antonio, Texas.**

**LETTER REPORT ON A HISTORIC BUILDING REVIEW OF A SPANISH
COLONIAL REVIVAL HOUSE LOCATED ON CULEBRA ROAD, SAN ANTONIO,
TEXAS**

By Mindy L. Bonine

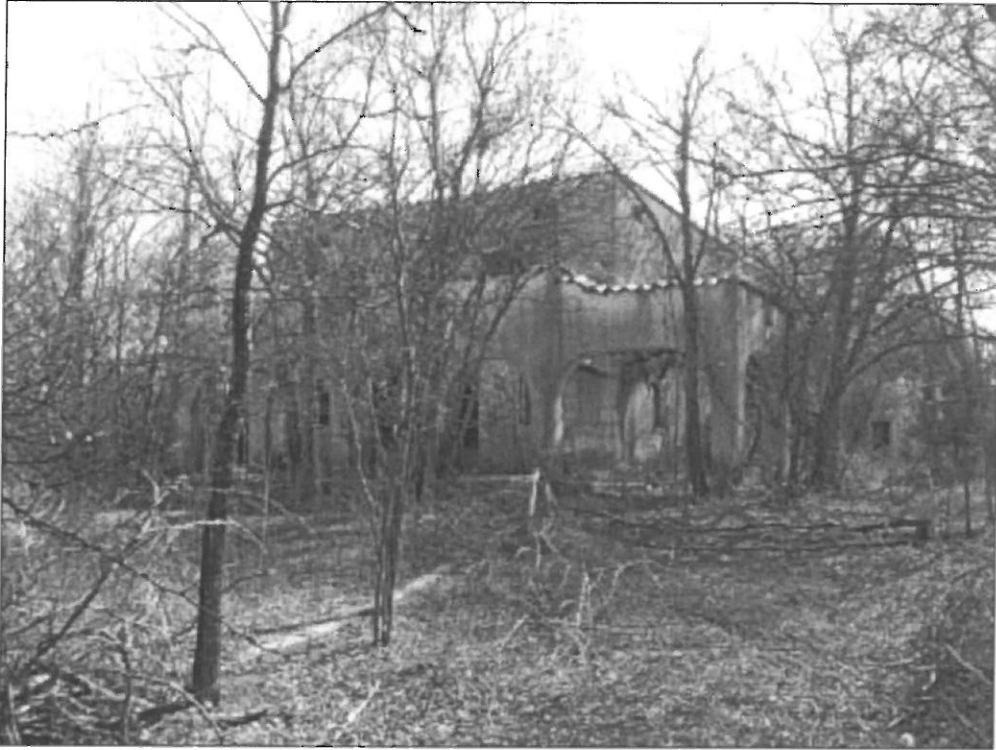
A site visit was conducted on February 27, 2006, and the house present in the project area was evaluated for its integrity and potential historic significance. The building is identified as a simple massed plan two-story house with a flat roof and parapet (Figure 2). A single-story front porch with a flat roof and arched entryways spans the entire façade and beyond to create two small wings. The walls are constructed of marl or very low-grade limestone blocks, which is

Figure 2. Façade of the stucco Spanish Colonial Revival house.

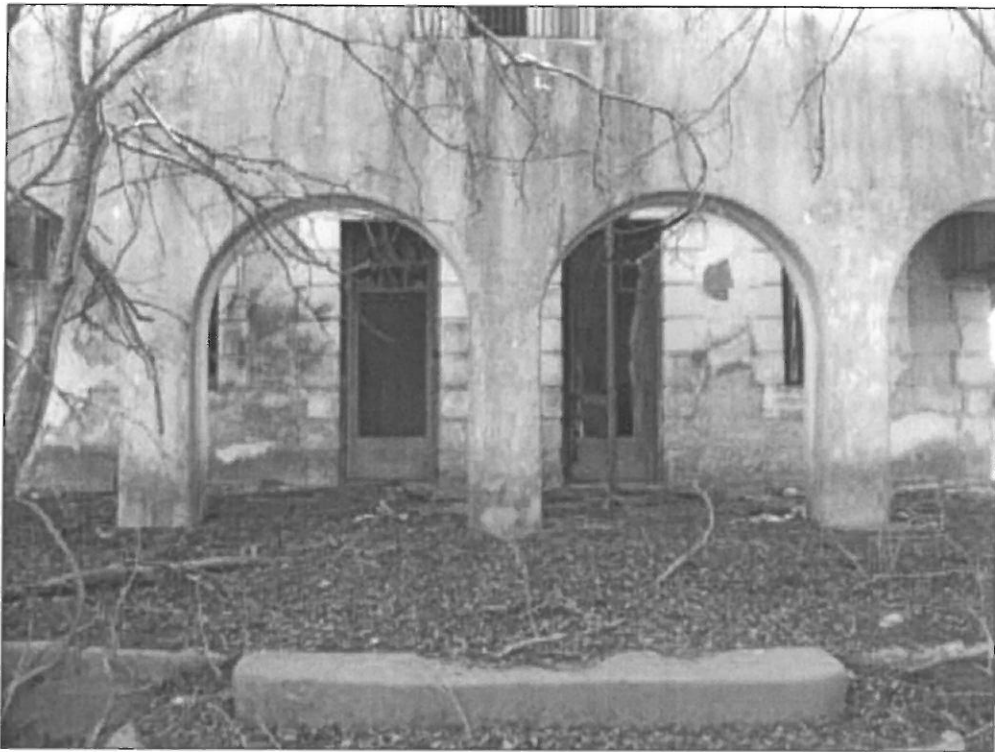
sheathed in metal lath attached with nails, and covered with white stucco (Figure 3). At least two additions to the house were observed, a single-story addition to the east side of the house and a two-story addition to the rear (Figure 4). The rear addition is built with the same marl or limestone blocks on the bottom floor and a wood-frame second floor. The original portion of the house contains a decorative cap on the parapet of straight barrel mission tile, while the additions have American Spanish Tile. The windows throughout the house are steel-frame casement windows (Figure 5), and the front doors (n=2) are comprised of wood frames and glass panels. The doors are about 2 feet wide. The exterior contains several decorative elements such as quoins along the corners of the façade and matching door surrounds, decorative stucco-covered stone lintels at the top of the front windows and doors, and tile decorative vents. These stylistic forms and materials conform to the Spanish Colonial Revival style (or as defined by McAlester and McAlester [2004], "Spanish Eclectic"), which was popular from 1915 to about 1940.

Figure 3. Two front doors of the house, note peeling stucco and nails.

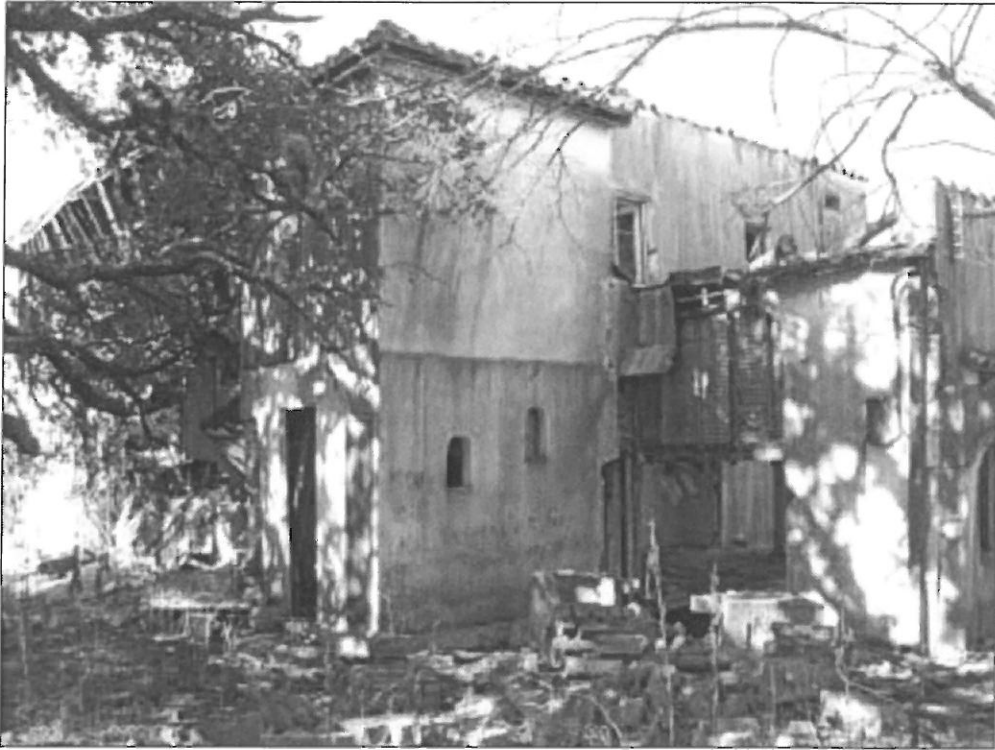
Figure 4. One-story addition (right) and two-story addition (left).

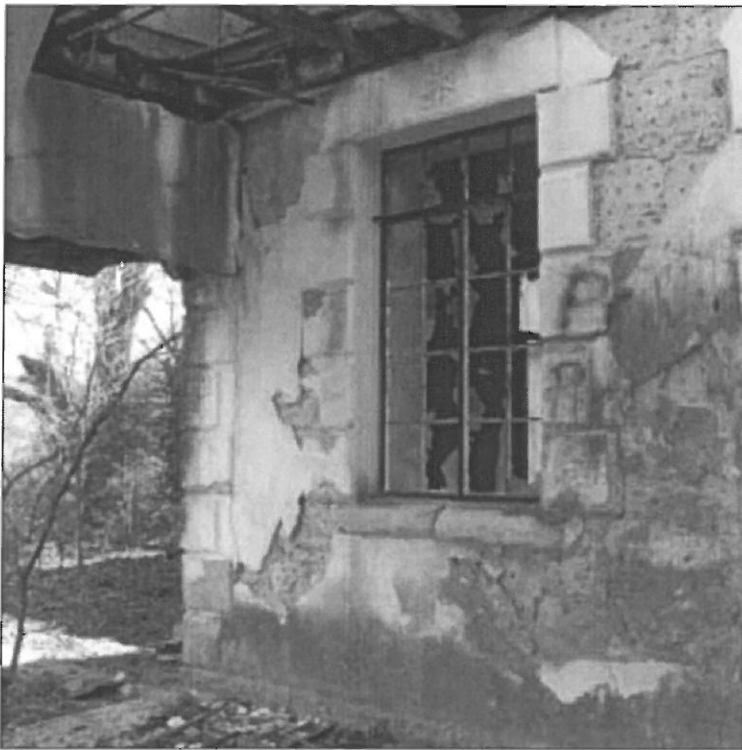
Figure 5. Steel frame casement windows and decorative lintel.

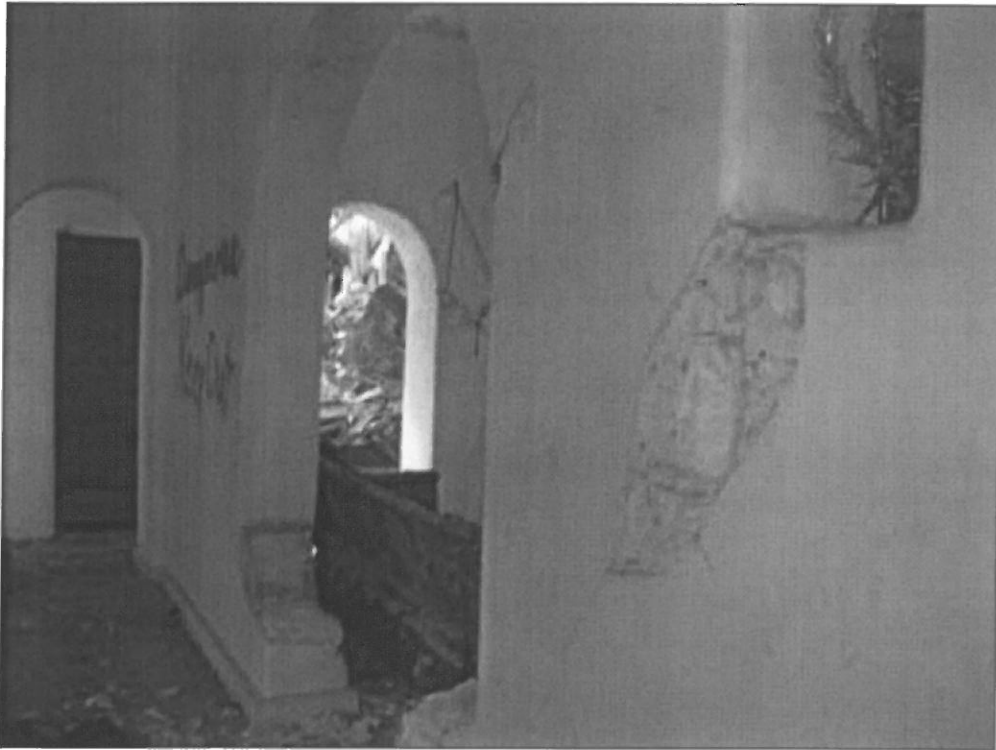
The interior of the oldest part of the house is divided into rooms by marl or limestone block walls covered with plaster (Figure 6). The ceiling and interior surfaces of the additions are finished with wood lath and plaster (Figure 7). Doors were not seen in many of the interior openings, which are primarily arched at the top. One fireplace was seen in the living area, and another toppled fireplace and chimney is attached to the one-story addition to the side of the house. An enameled cast-iron claw-foot tub was seen in the bathroom, and the kitchen contains plywood cabinetry and sea-green 4-x-4-inch tile countertop and backsplash. Floor tile was observed in the kitchen, but the remainder of the house is covered with tongue-and-groove hardwood flooring. Numerous sections of the house have decayed and fallen in, including the roof of the front porch, several sections of interior plaster, the roof of the rear addition, and the entire wall containing the fireplace chimney of the one-story addition. The exterior wall of the second story rear addition has tilted inward and all of the exterior stucco has fallen off (Figure 8), and the round stucco-covered stone cellar is exposed (Figure 9). Several sections of the house could not be accessed due to the damage, including the second story.

Figure 6. Interior living area.

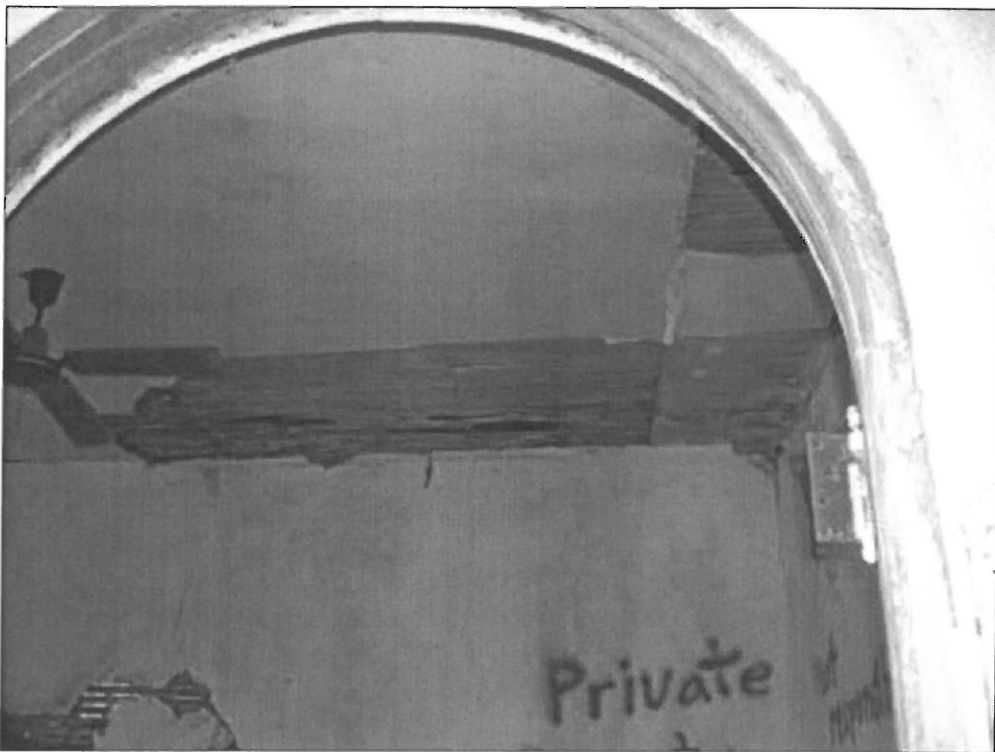
Figure 7. Lath and plaster ceiling.

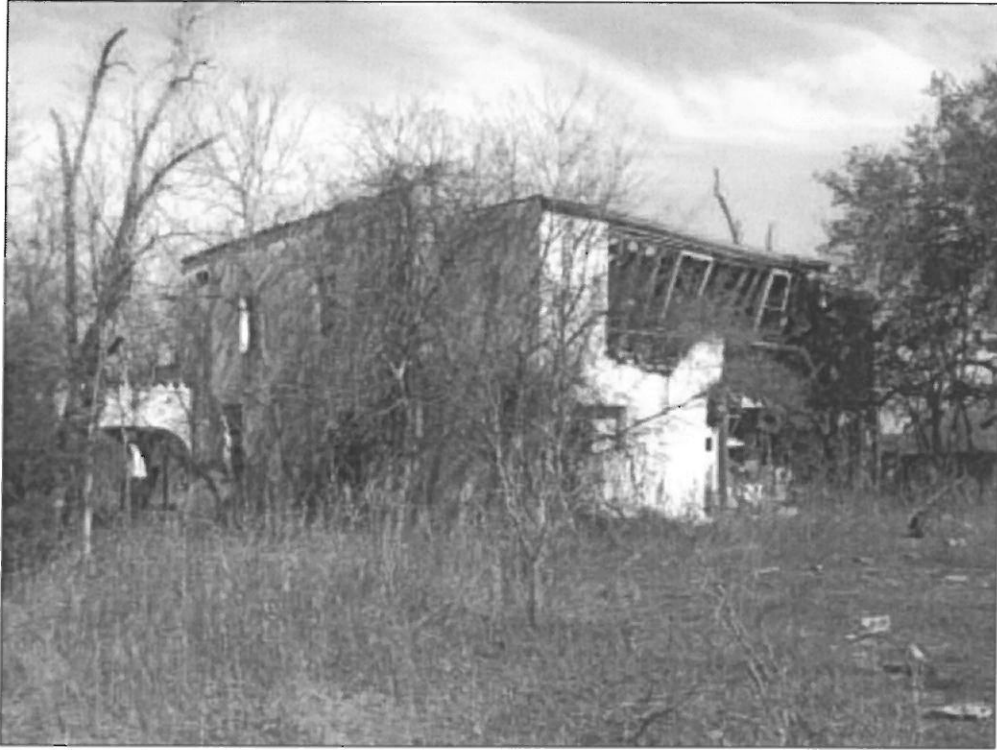
Figure 8. Rear of stucco house, showing collapsed second story.

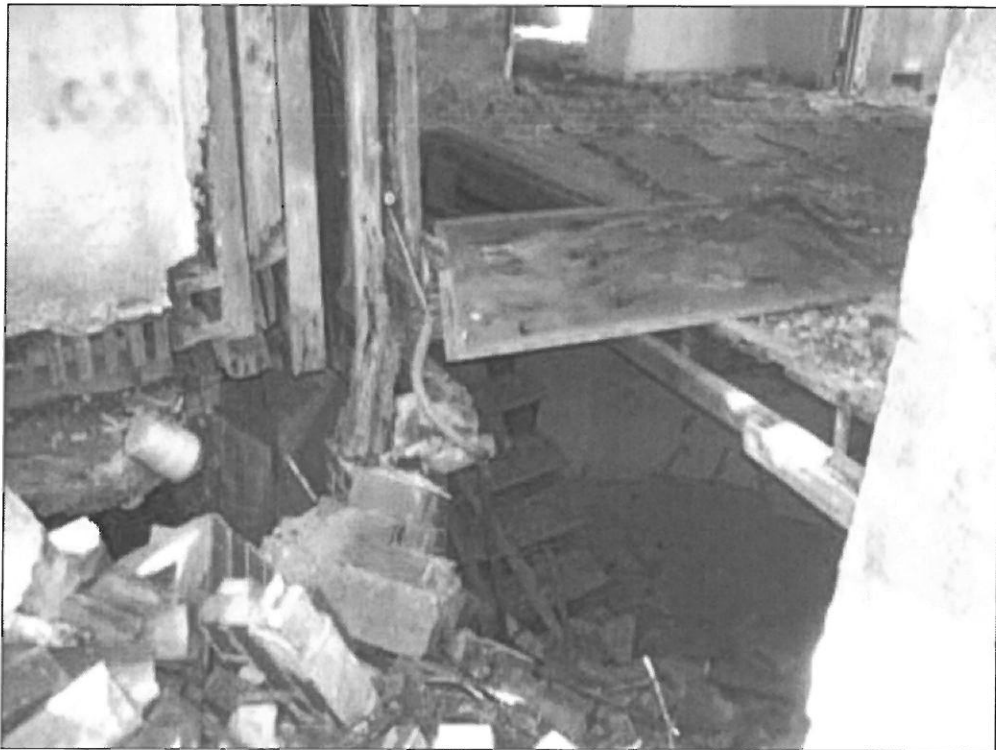
Figure 9. Collapsed chimney to the lower left of photo, revealing round cellar.
